Assessment of Polybutylene Plumbing Installation after 18 Years of Service

Dale B. Edwards and Donald E. Duvall
Engineering Systems Inc., Aurora, IL 60504

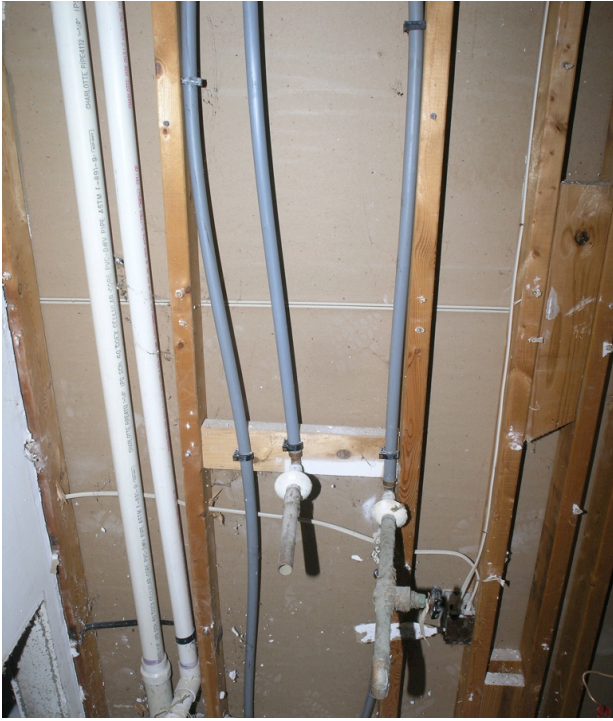
In general the installation of the PB pipe in the apartment complex was excellent. The tubing was properly secured to studs and was not excessively bent. Approximately 18 inches of copper pipe was present between each water heater and the beginning of the PB hot water piping. The system utilized wrought copper fittings and either Qest or Vanguard 3/4" PB tubing. The crimp ring diameters were

Figure 1. Typical layout of PB piping in a first floor apartment.

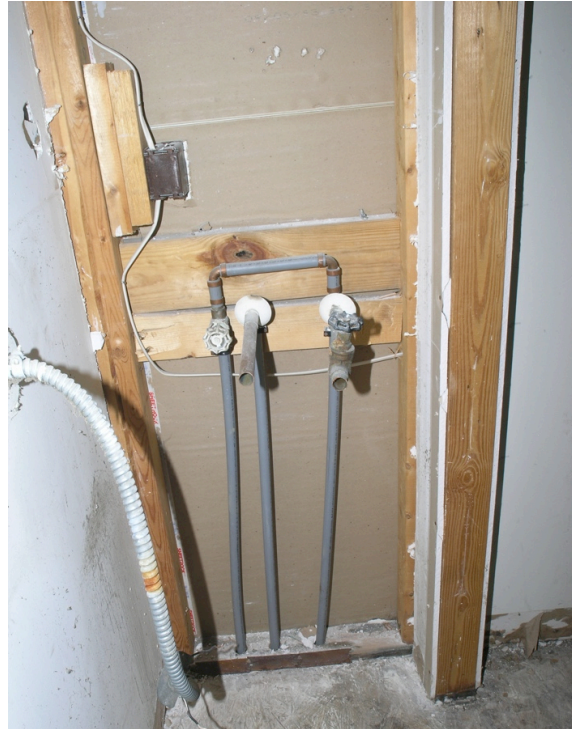
Figure 2. Typical layout of PB piping in a second floor apartment.

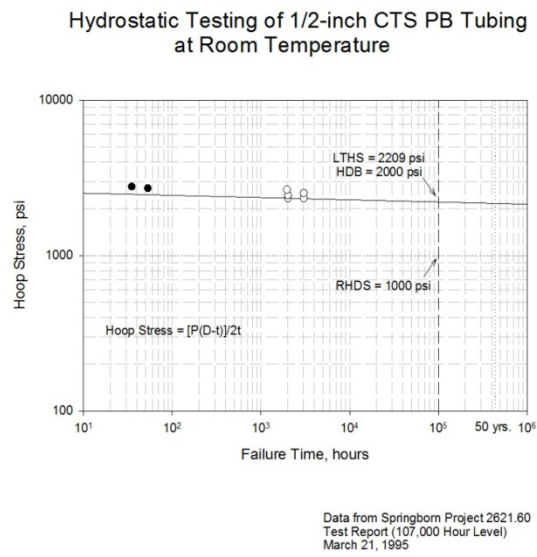
The E-2 data set includes a minimum of 10 data points with failure times ranging from 10 to more than 2000 hours. This data was then analyzed according to the procedure in ASTM D2837 to estimate the hydrostatic design basis (HDB) for the PB samples. The data were plotted on a graph with 107,000 hours of long term hydrostatic test data obtained on new, unused PB pipe that was reported by Springborn Laboratories in 1995 [8] (Figure 3). This testing continued for more than 3000 hours and established that the long-term sustained pressure performance of the pipe is comparable to or better than published data on new, unused PB pipes. The pipes have surpassed the expected failure times at the test hoop stresses, as shown in Table 6 below.

Figure 3. Hydrostatic pressure test results (symbols) superimposed on results of testing of new, unused PB pipe (line).
