Polybutene
Piping Systems Association

Polybutene-1 Piping Systems

Answers to Frequently Asked Questions

Assessment of Polybutylene Plumbing Installation after 18 Years of Service

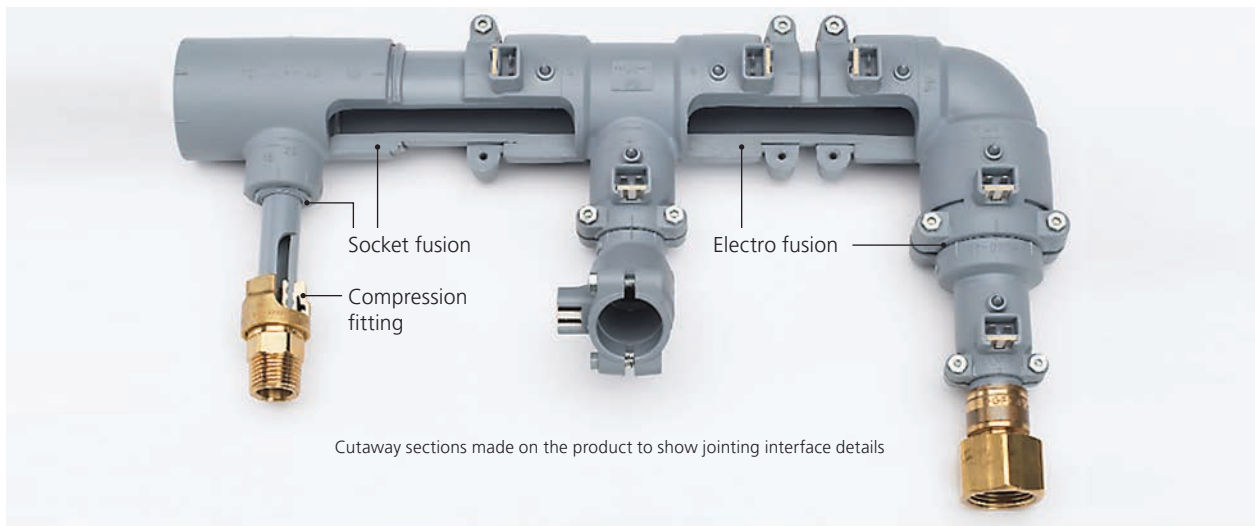
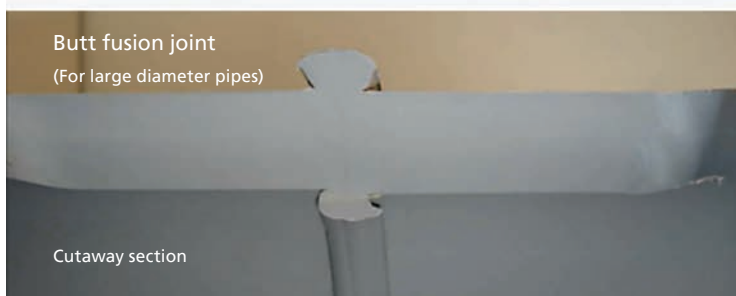
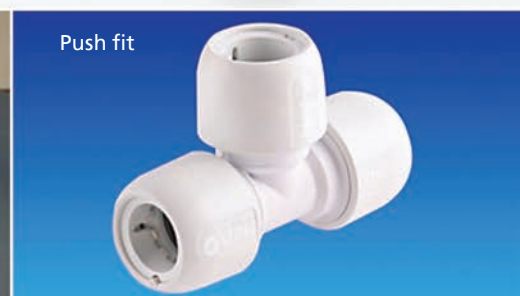
In contrast to the US examples are typical examples (below) of the types of fittings developed over many years which are an integral part of the success of today's Polybutene-1 piping systems in the European and Asian markets.

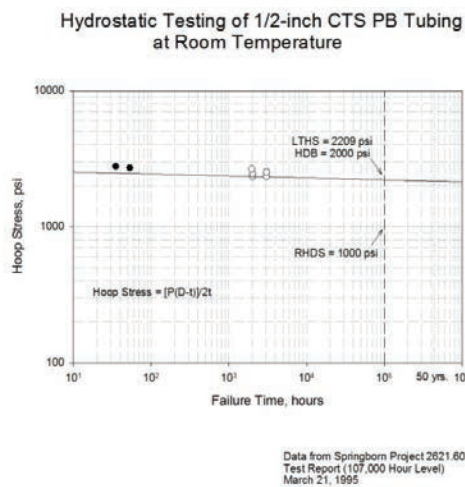
Figure 3. Hydrostatic pressure test results (symbols) superimposed on results of testing of new, unused PB pipe (line).

Hydrostatic stress rupture tests are being performed on samples of the PB pipe removed from the apartment complex. This testing is above and beyond the required 1000-hour sustained pressure tests called out in ASTM D3309 for the pipe. Testing was initiated on the PB pipe samples following the protocol in ASTM D 2837 [6]. In this case testing was initiated to obtain an E-2 data set (per Plastics Pipe Institute TR-3 [7]) to demonstrate how the 18-year-old PB pipe compares to the stress rupture data for new, unused pipe.

The E-2 data set includes a minimum of 10 data points with failure times ranging from 10 to more than 2000 hours. This data was then analyzed according to the procedure in ASTM D2837 to estimate the hydrostatic design basis (HDB) for the PB samples. The data were plotted on a graph with 107,000 hours of long term hydrostatic test data obtained on new, unused PB pipe that was reported by Springborn Laboratories in 1995 [8] (Figure 3). This testing continued for more than 3000 hours and established that the long-term sustained pressure performance of the pipe is comparable to or better than published data on new, unused PB pipes. The pipes have surpassed the expected failure times at the test hoop stresses, as shown in Table 6 below.
